SOLUTION STORY

SICK USM Water Ingress

MetSolv

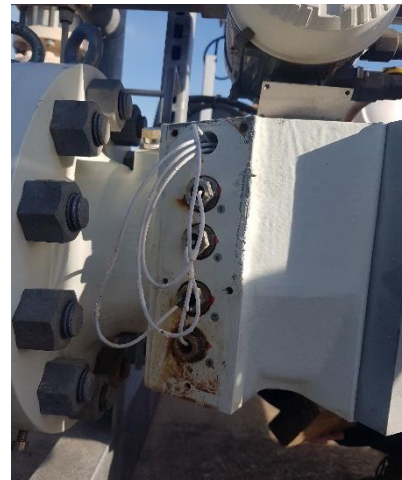
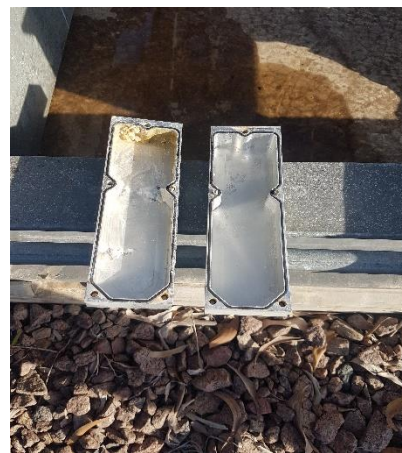
The transducer cover was removed from the flow meter to reveal approx. 300-400ml of water ingress and a lot of corrosion. The corrosion was cleaned, and the cover left off to dry the transducers and cables out, this resulted in a slight improvement, however the bulk of the damage had already been done.

With Metsolv's flow metering expertise it was known to replace the path 2 transducers and all transducer cables along with a new transducer housing cover and seal to maintain the flow transmitters integrity.

Spare materials were ordered, and the rectification work carried out on site by a Metsolv Technician.
