## SOLUTION STORY

### S600 Battery Failure & Upgrade

# MetSolv

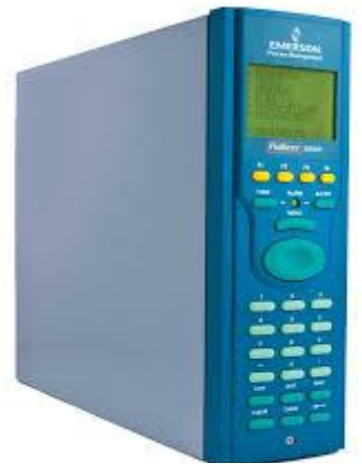
A client was receiving numerous battery fail alarms on their S600 flow computer. The backup battery retains power to the flow computer in the event of a power outage, without an effective backup battery the flow computer configuration would be lost and the flow computer would not be able to boot back up.

The client attempted to replace the battery as per an Emerson battery backup changeout procedure, however when rebooting the S600 flow computer the screen displayed "RESETTING" and failed to boot up.

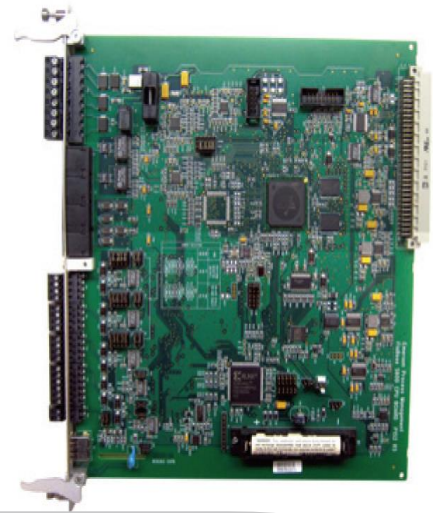
Upon MetSolv's investigation it was deemed the configuration and the firmware had been lost and the card required repair.

MetSolv's experience of the S600 provided us with the knowledge to recommend upgrading the two S600's to S600+'s, which involved installing upgraded CPU boards. The new CPU boards have push in mounted batteries rather than a soldered battery for ease of replacement.

To ensure that flow through the metering station was maintained MetSolv developed a testing schedule that would ensure no down time and that flow continued to be accurately measured.

A site acceptance (SAT) manual was developed to provide a documented testing approach during MetSolv's site work.

Flow computer functionality testing was completed to confirm the flow computer operation was maintained.
